## Higashi Honganji Temple in Kyoto

ALGAL BLOOM PREVENTION AND  
WATER QUALITY IMPROVEMENT

WITH NANOBUBBLES AND  
PROBIOTICS. AT A MOAT IN A  
TOURIST AREA.

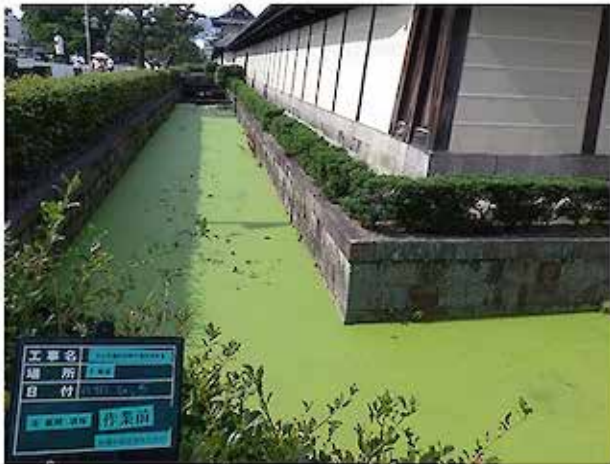
## before

On the other hand, tourism in Kyoto was on the rise and more and more, litter came in the moat. This led to an uncontrolled situation of bad smell, fish mortality, opaque water and the bottom of the moat was invisible. In the summer, algal blooms were becoming more and more frequent.

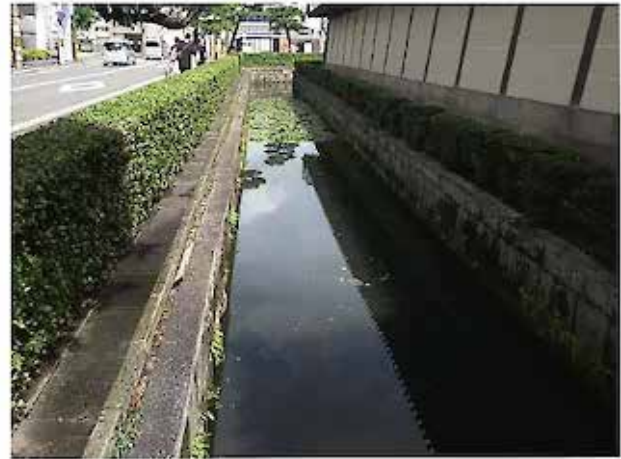
## after

Three months into the project the results became visible. No more smell and fish mortality, and the water color went from opaque to transparent clear. Depending on the climate conditions in spring and summer, there is a more intensive cleaning program with longer hours for operating the nanobubble generator. During the summer, peak they run max 13 hours from 6 PM to 7AM always around sunset till sunrise.
