Case Study: Herreruela & Carcaboso – Cáceres

Company:	Herreruela & Carcaboso
Location:	Spain
Year:	2011-2012
Description:	Supply of drinking water treatment system to the cities of Herreruela and Carcaboso in the province of Cáceres, Spain
Goals:	Reduce arsenic and iron levels
Capacity:	Herreruela: 200 m ³ /day Carcaboso: 400 m ³ /day
Water Source:	Tube wells

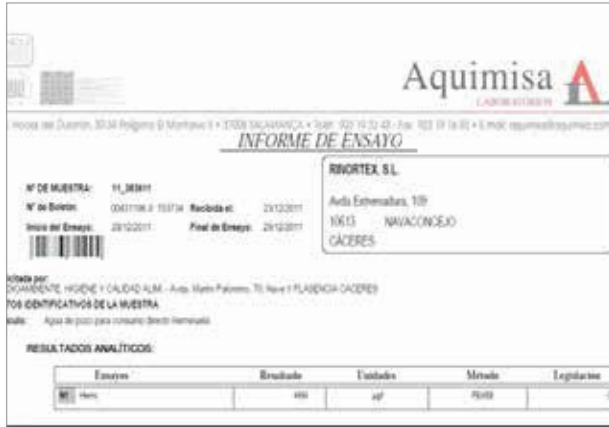
Before Treatment: Iron = 4484 ug/l

Herreruela Parameter	Required Value	Before Treatment	After Treatment
Turbidity (NTU)	< 1	5	< 0.5 ✓
Arsenic (ug/l)	< 10	45	< 10 ✓
Iron (mg/l)	< 0.2	4.48	0.14 ✓

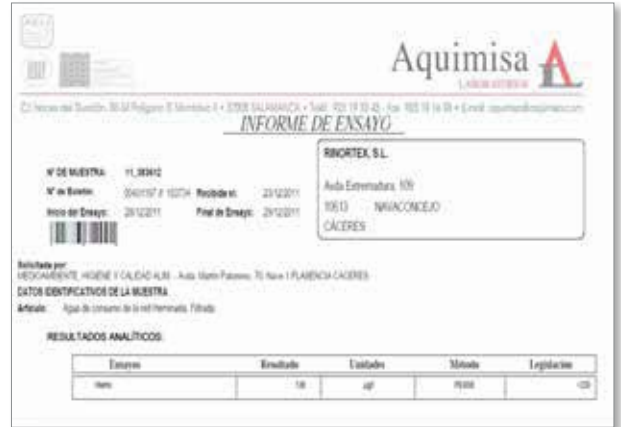
After Treatment: Iron = 139 ug/l

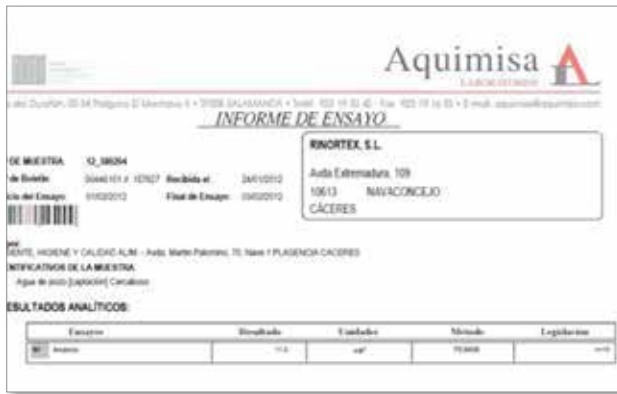
Before Treatment: Arsenic = 11.0 ug/l

Carcaboso Parameter	Required Value	Before Treatment	After Treatment
Turbidity (NTU)	< 1	5	< 0.3 ✓
Arsenic (ug/l)	< 10	11	< 3 ✓
Iron (mg/l)	< 0.2	2.3	< 0.12 ✓

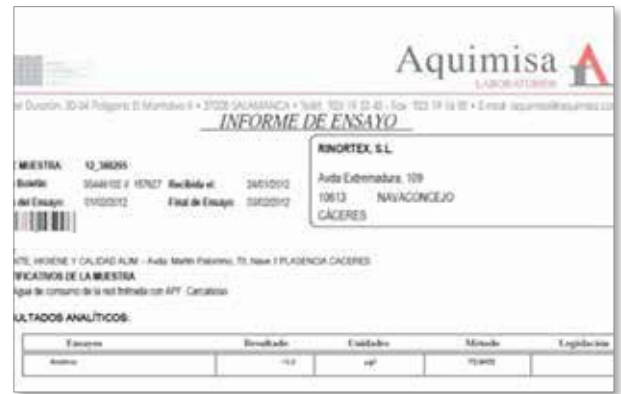
After Treatment: Arsenic = <3 ug/l
